The Locomotive

THE HARTFORD STEAM BOILER INSPECTION AND INSURANCE CO.

VOL. XL

HARTFORD, CONN.
1934-1935

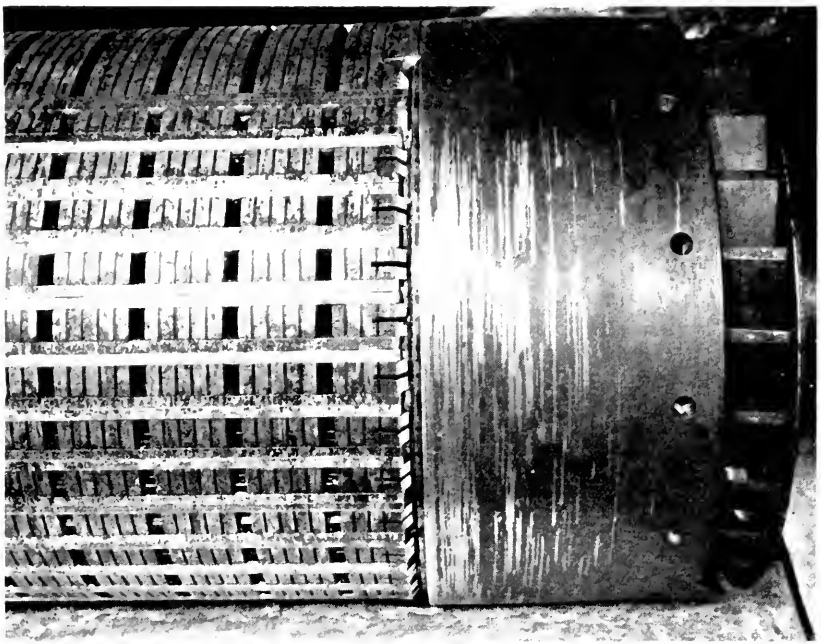
Damaged rotating field after over-speed. The core is a solid steel forging so machined that the forged steel end rings are fitted into a rabbet-joint on the ends of the rotor forging. The centrifugal forces exerted against this rabbet were sufficient to break off sections of the steel rotor forging, which immediately jammed between the field and stator where they were rolled into small balls or were embedded in the stator laminations.

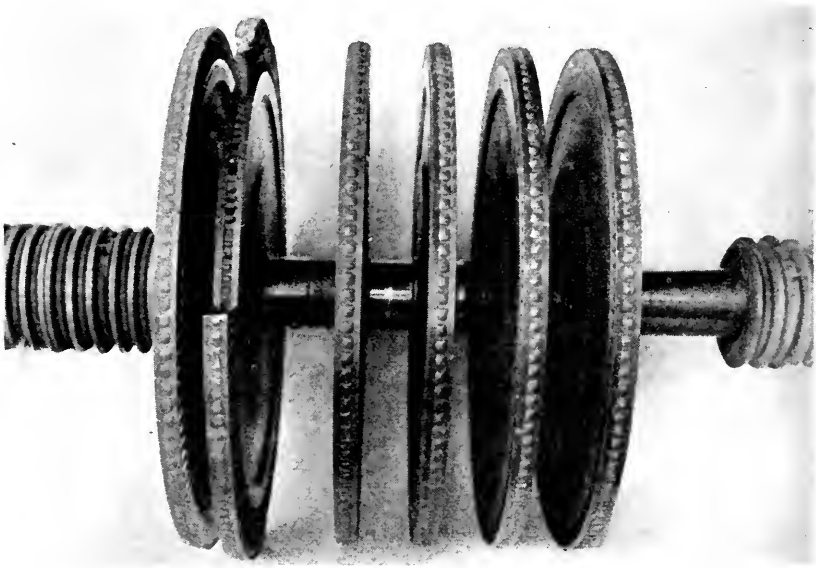
Wheel from which 24 blades were broken when water forced it out of line and permitted it to rub.

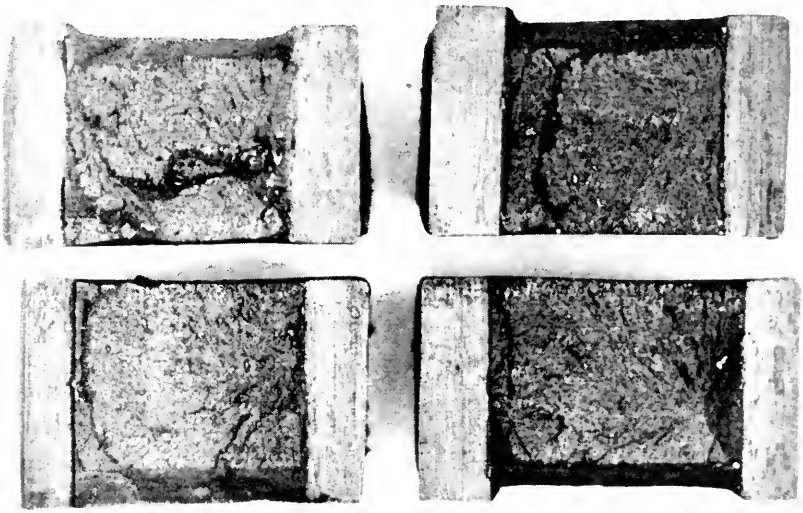
Figure 8

The side break test is somewhat new. It had been felt that the nick break specimen might not reveal defects that might exist on the side walls of the welding groove. To investigate this matter a defective weld was made in which there was a slag streak of somewhat minor proportions on the side wall. The weld was X-rayed and it was found that the defect continued throughout the length of the weld. Four nick break specimens and three side break specimens were removed. Two of the nick break specimens were broken in the customary manner with a quick, sharp blow, and the other two nick break specimens were broken by a slow bending. All of the nick break specimens broke directly through from notch to notch as shown in Figure 8. The side break specimens broke through the side wall defect as shown in Figure 9.

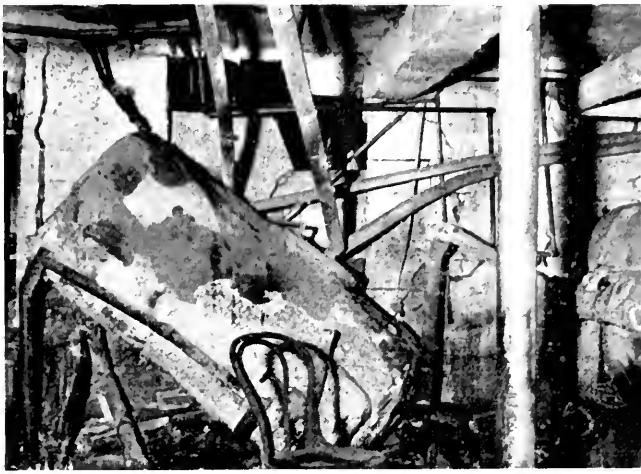
Upper Right—A hot water heater failure in a Pennsylvania business block injured a woman and resulted in property damage estimated at $5,000. The blast tore loose the 750-gallon hot water tank shown in the photograph. **Lower Right** — A welded quill pipe steam radiator exploded, scalding an employe and damaging equipment, walls and show window of an Iowa shop. Windows were shattered in automobiles parked in the street in front of the store.

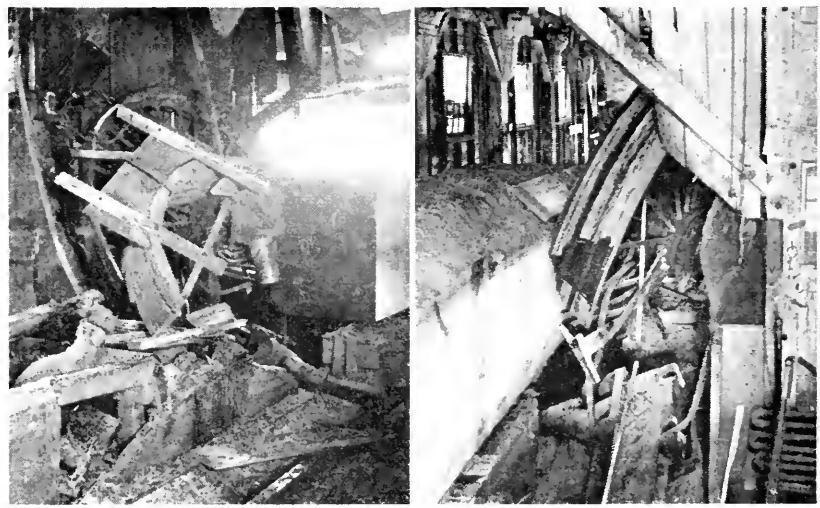
Wreckage following a band saw wheel explosion at a Western mill.

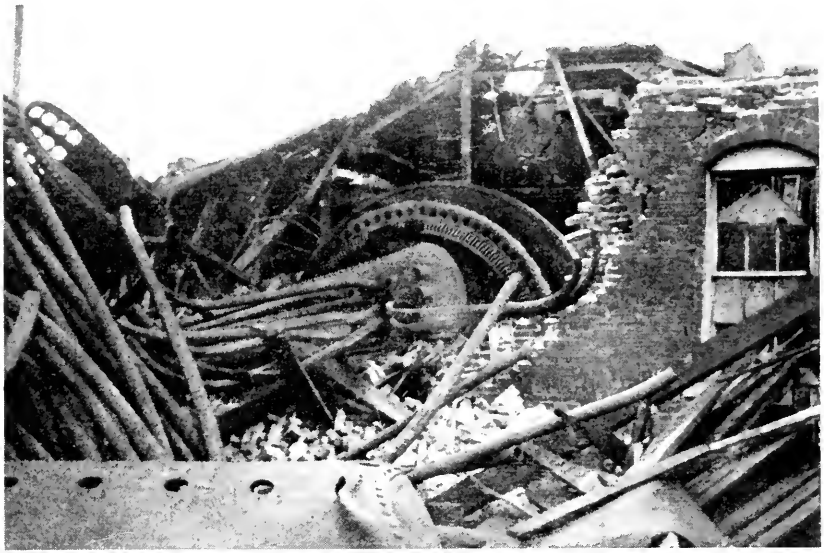
Wreckage following a lower drum failure at a Middle-Western utility.

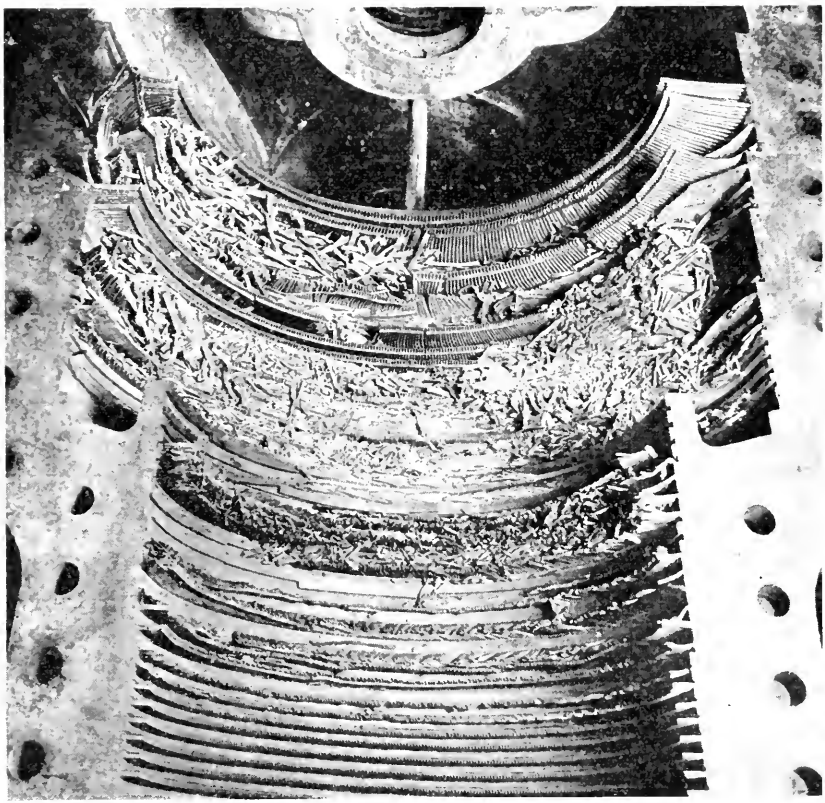
Figure 3—Casing of 1875 kva turbine after several blades broke out. The rotor was stripped of practically all of its blading.

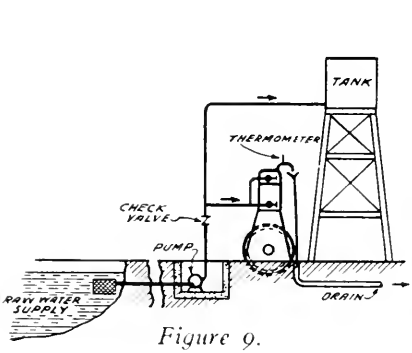
Figure 9.

Examples of typical OPEN TYPE Diesel Cooling Systems.

seasons of the year, contain large quantities of suspended matter which are deposited in the cylinder jacket as a soft mud. There have been many piston seizures, excessive cylinder distortions and cracked heads directly caused by a water source becoming suddenly very muddy after a long spell of heavy rains. This hazard is present in connection with the continually wasting type of open system, as shown in Figures 9 and 14, as well as with the recirculating type of open system shown in Figure 11.

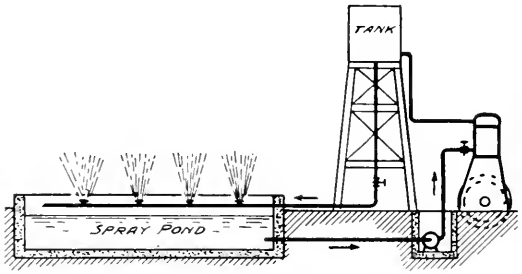
Figure 11.

Another serious trouble that has been experienced with the use of the recirculating type open system is the obstruction of the piping and water passages through the jackets by foreign material such as lint and dust from manufacturing processes. Such material drifts into spray ponds and into open receptacles under cooling towers.

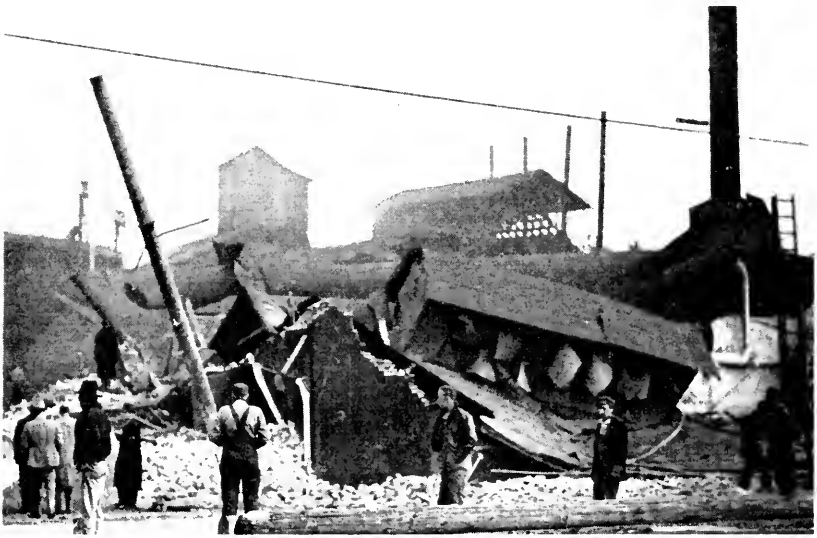
Result of external corrosion of a blank head in a bent tube type boiler.

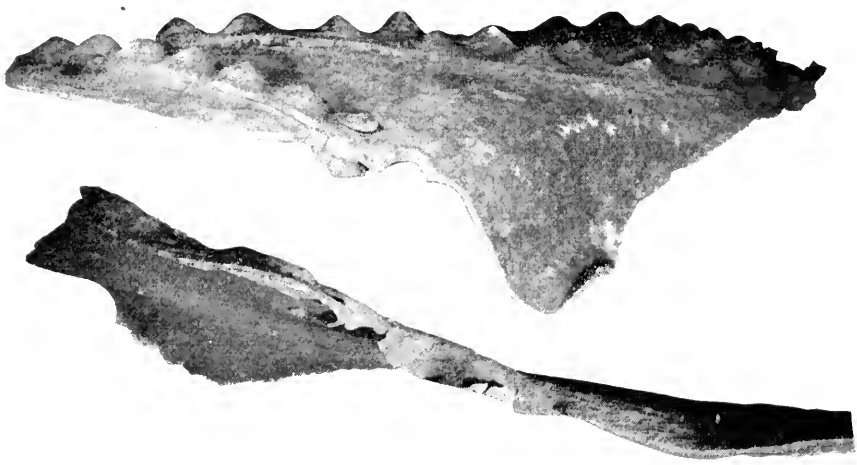
Typical thinning because of external corrosion in boiler plate originally 7/16" in thickness. In places this plate had thinned to less than 1/8".

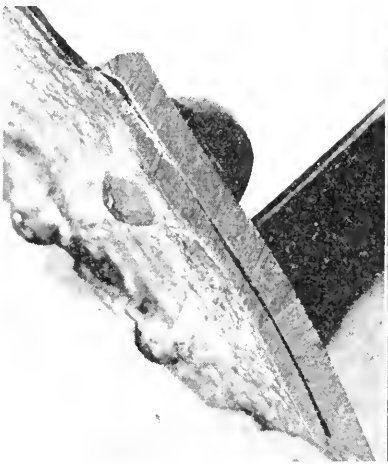
Figure 2

exploded at its normal operating pressure of about 100 lb, the outer lap of the rear course tore along a line about ¾″ from the edge of the inner lap and parallel with the girth seam. The fracture extended through the girth seam and then tore almost all the way around the other course.

Although the vessel had been in use for only two years, the plate had been reduced on the average to about half of its original thickness and the wasting was quite general.

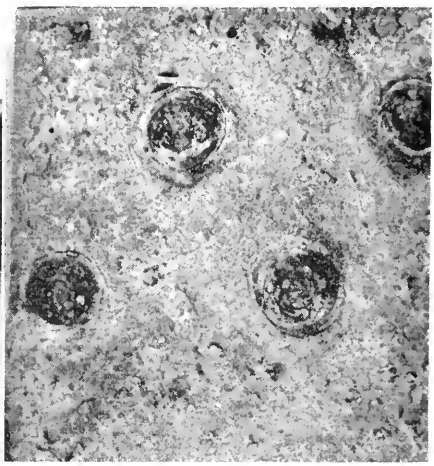
Figure 3

The vessel was destroyed by the explosion, its contents were badly damaged, asbestos was scattered throughout the large room, (120′ by 165′) and condensed steam saturated all the equipment there. Many panes of glass were broken and the metal sash supporting them was bent. Of the 22 men in the room at the time 20 escaped without injury. The other two received minor cuts and bruises.

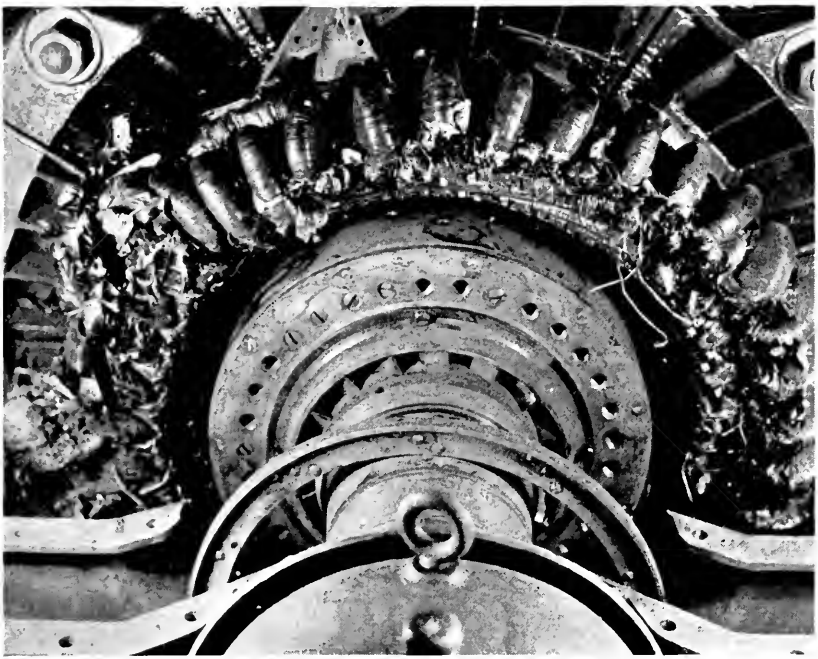
After the cooling fan cut into the windings. A piece of the broken fan may be seen at the top of the stator.

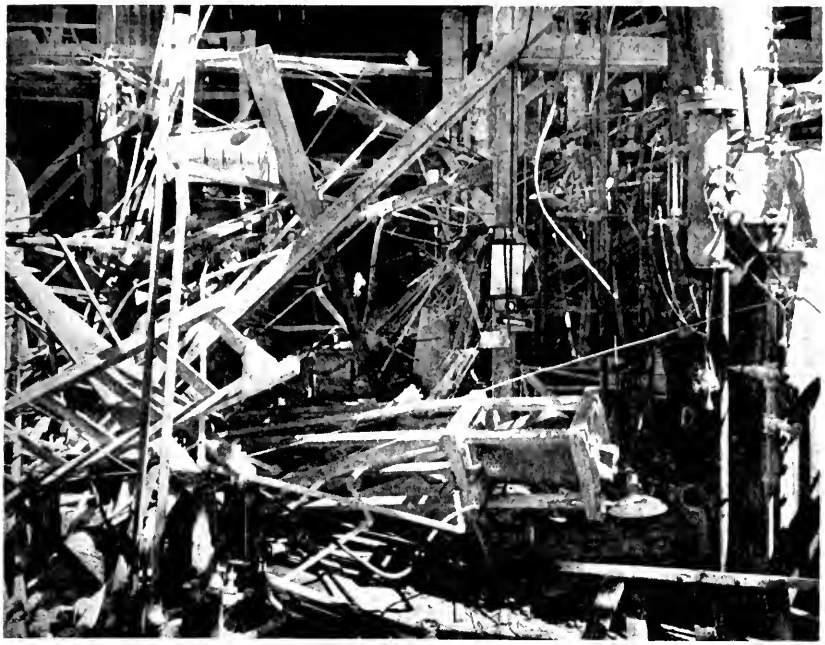
Figure 2. Wreckage caused by the explosion and the subsequent collapse of the building.

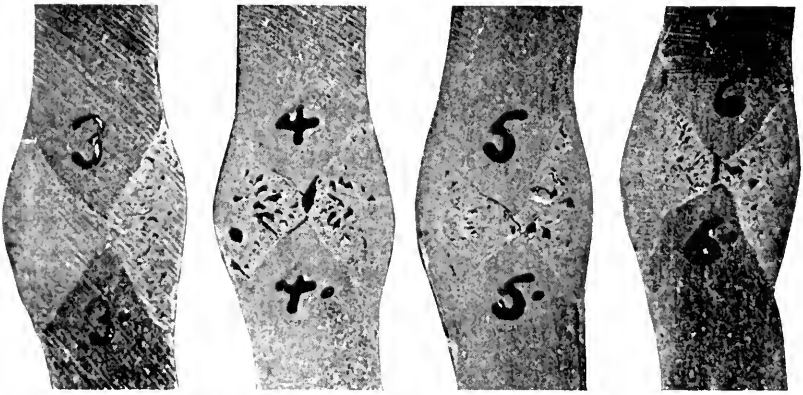
Examination of the weld metal, as illustrated in Figures 3-6, revealed a definitely defective weld, which, coupled with the fact that the vessel was subject to periodic fluctuations of pressure and temperature, may have combined to bring about the failure which occurred during its normal operation.

Figures 3-6. Etched specimens of welds from the vessel which failed, showing lack of fusion and general porosity in specimens 4, 5 and 6.

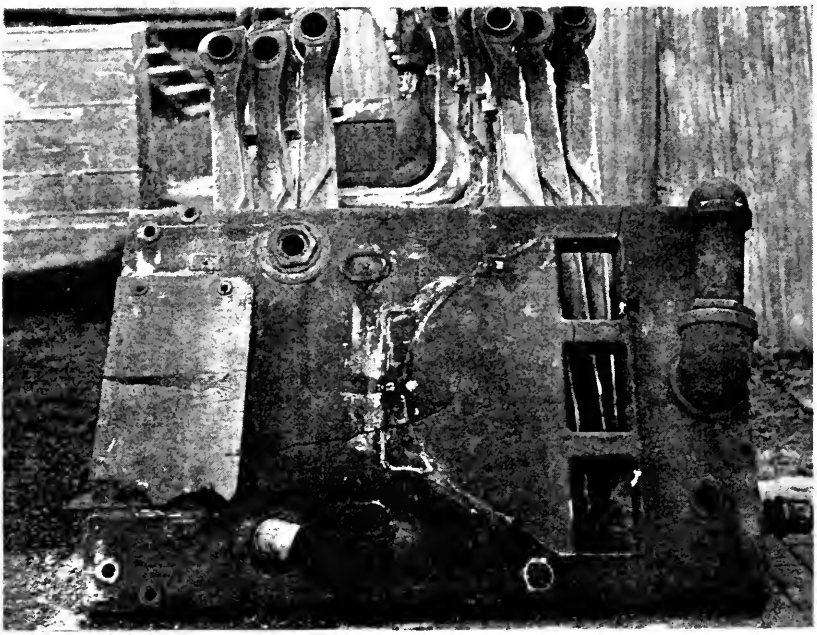
Figure 1. Cracks in a cast iron section—never a spectacular accident but the most frequent of all failures of heating boilers.

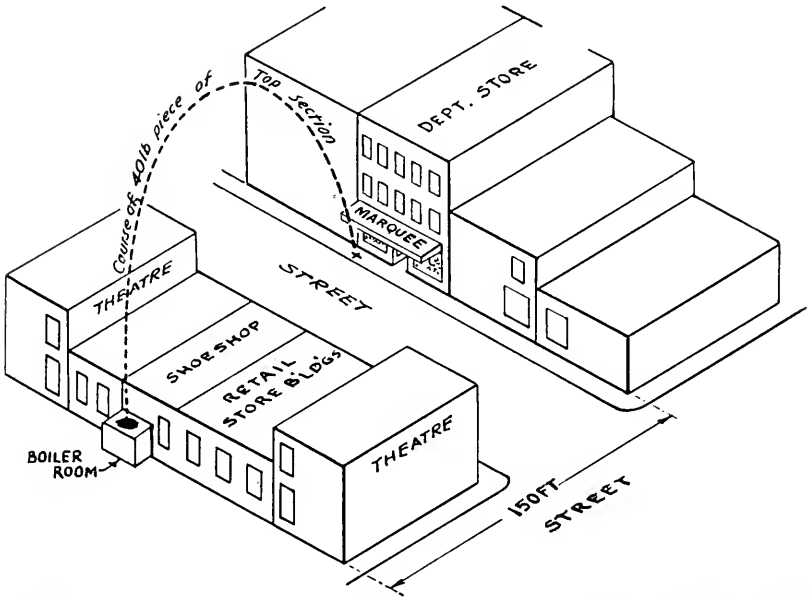
Figure 3. Course of travel of the top of a hot water heating boiler that exploded because of over-pressure.

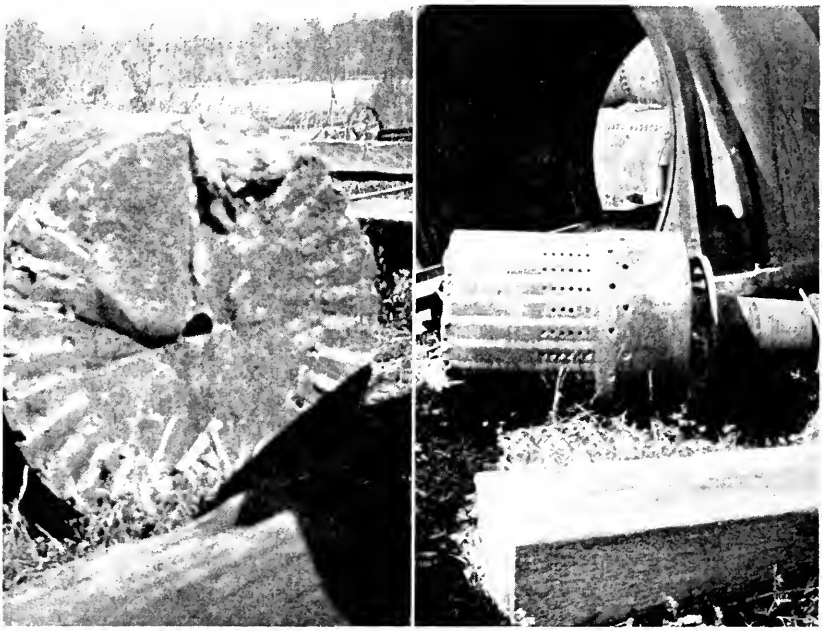
Generator rotor which exploded.

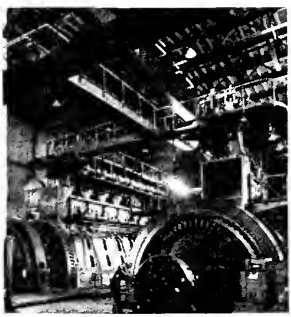
avoid injury, jumped from a window and broke his ankle, and another received minor injuries because of flying metal. A turbine erector, who tried to knock out the emergency trip by hand, reported that he found it was already out. Damage was estimated at $20,000.

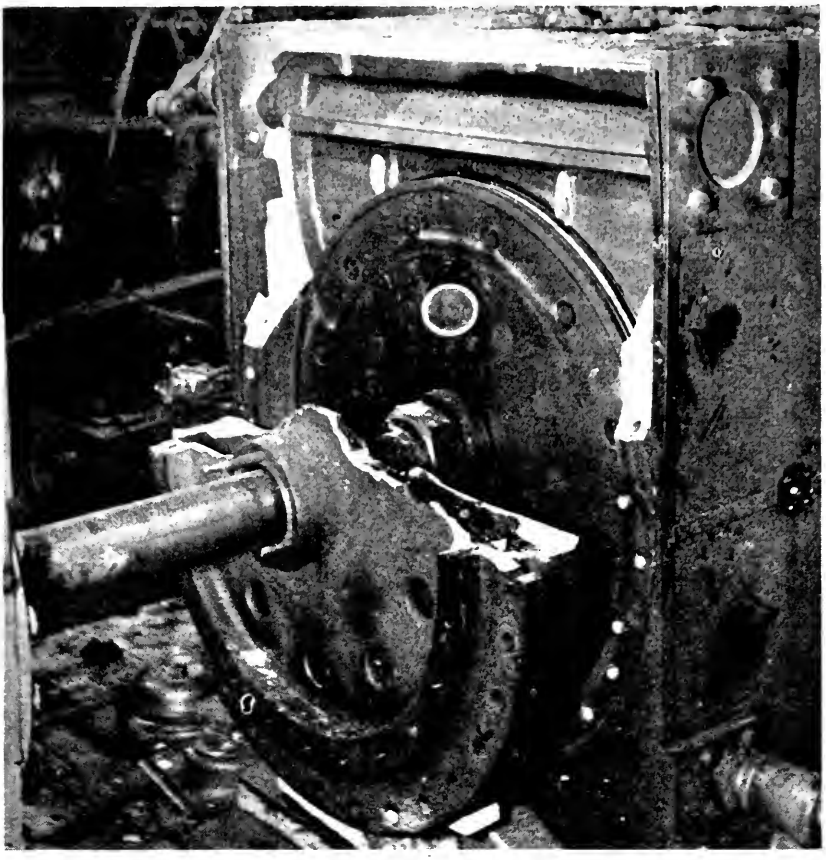
Figure 1—Cylinder wrecked because of connecting rod failure. The damage is typical of accidents from this cause.

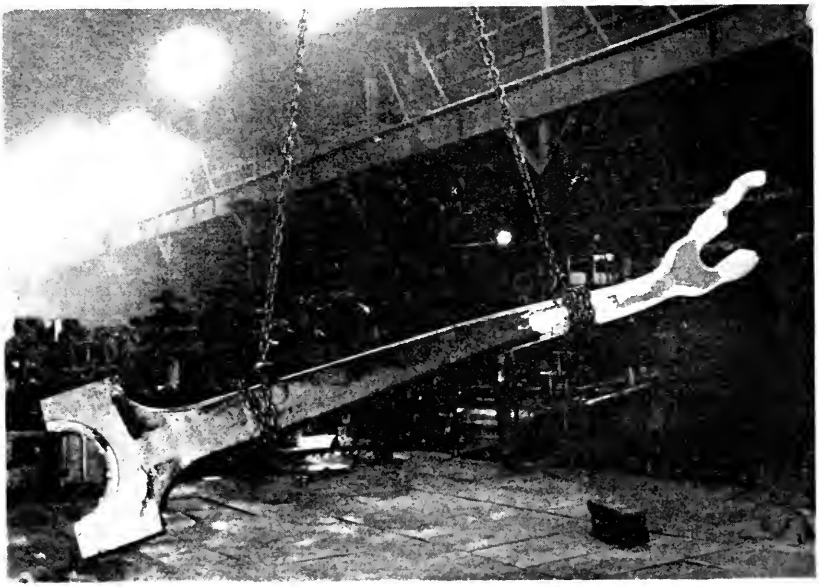
Figure 4—Typical break of the rod-end in a large Corliss engine.
